ABE Enterprises, Inc.

Atlanta, GA

Background & Project Challenges

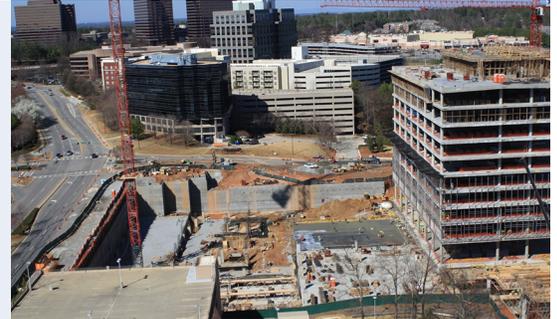
Geocomp monitored lateral movements and settlement of the excavation support system (ESS), existing parking deck and road adjacent to the 35' deep excavation. The movement was monitored using a robotic total station and 65 survey prisms. Nearly 9" of lateral movement into the excavation and 11" of settlement was experienced at one point next to a major road that developed over a long holiday weekend. Alerts from Geocomp's *iSiteCentral*TM brought site personnel back in to take remedial measures to stabilize the situation. These remedial measures were evaluated for effectiveness by Geocomp.

There was a concern that the vertical movements were caused by excessive bearing loads at the base of the soldier piles for the ESS from the vertical components of the ground anchor forces. Geocomp performed a drained and undrained finite element analysis and determined that a large component of the vertical force was ongoing consolidation of the dewatered silt and silt sand. The deformations were further exacerbated by excavations made near the toe of the wall for a tower crane pad, and low factors of safety against global stability.

Geocomp used the results from the finite element model to evaluate remedial measures which included installation of a fourth row of tiebacks in one area and installing a row of auger cast piles at the toe of the wall. The auger cast pile solution was beneficial to the project cost and schedule because the contractor was already on-site installing auger cast piles for the proposed building. Geocomp worked with the structural engineer to identify surplus capacity in the foundation auger cast piles and reduce the number of piles required to increase the global stability of the wall.
