University of Northern Iowa

- Design and installation of structural health monitoring system during stadium roof retrofit and restoration
- Service and restoration of system components for long-term reliability

Background & Project Challenges

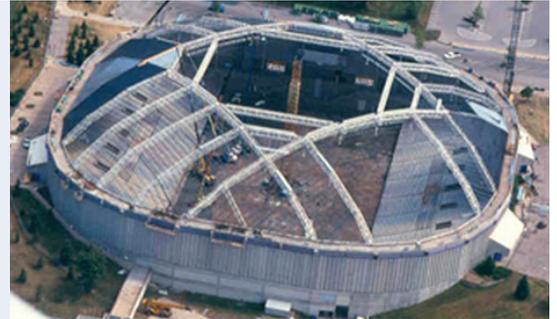
In 1998, a hybrid roof system was installed to replace the air-supported roof. Stainless steel standing seam roof panels supported by structural metal deck and bar joists formed the skin of the peripheral area of the roof (75% of the roof area). The 45,000-sq-ft center polygon is enclosed with an arch-supported, PTFE fabric tensile roof. The new roof system, further modified since the 1998 reconstruction, utilizes a snow-melting system to prevent snow from accumulating enough to damage the roof structure. As a backup measure, a structural monitoring system was installed as part of the roof system retrofit.

In 2003, Geocomp personnel designed and installed a structural monitoring system for the roof members, to measure excessive or eccentric snow loads on the roof skeleton. The structural monitoring system includes wind speed and direction sensors and strain gages placed on key structural elements near the top of the roof on the central ring beam system.

Strain gages were placed on ring beam structural elements to identify stresses that may approach levels where maintenance staff may be required to visually inspect roof conditions for excessive snow loads. The strain gages connect to a data logger that issue an alarm if assigned response values for calculated stresses are exceeded for any sensor. The system is accessed remotely for software modification or data retrieval.
