Instrumentation Plan for Monitoring the New I-10 Twin Span Bridge

89th Transportation Research Board Annual Meeting
January 10-14, 2010
Washington, D.C.

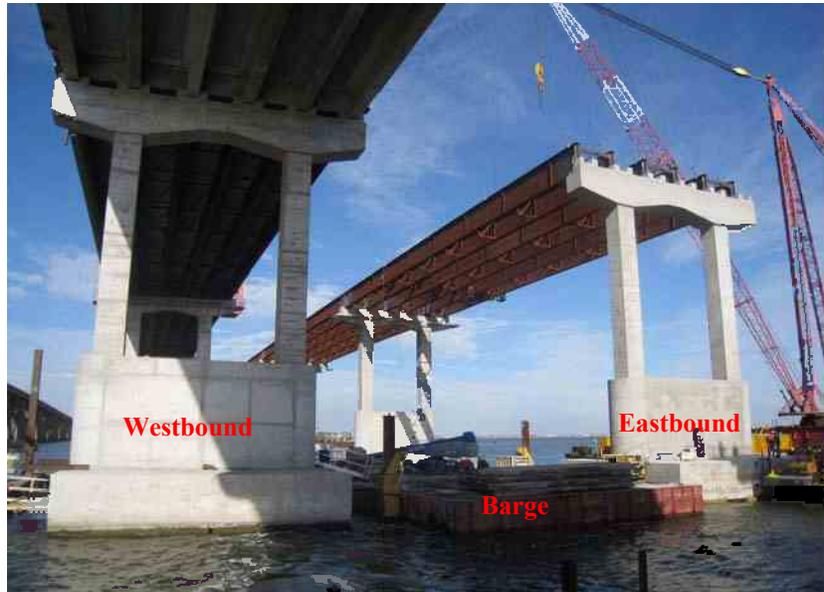
LADOTD selected the M19 eastbound pier at the main span of the bridge to install a structural health monitoring system, which includes both substructure and superstructure instrumentations for use in short-term and long-term monitoring of the bridge. The M19 pier supports 200-ft. long steel girders in the north side and 135-ft. long concrete girders in the south side. The bridge foundations consist of square precast prestressed concrete (PPC) piles. The foundations of M19 eastbound and westbound piers consist of 24 PPC 110-ft. long battered piles (batter slope 1:6) with an outer dimension of 36 in. and a circular void of 22.5 in. The average pile embedded length was 87 ft. The size of pile cap (or footing) of the M19 piers is 44 ft. × 42.5 ft. × 7 ft. The water depth is 11 ft. Figure 1 presents the M19 eastbound and westbound piers site.

Figure 1. Photo of M19 Eastbound and Westbound Piers Site

The substructure monitoring system was temporarily assembled two days before the test to allow the collection of data from all instruments during the lateral load test. This includes connecting the IPI sensors and strain gauges to data loggers that were housed inside the eastbound pier protection wall. Data loggers were then connected via internet phone to the data acquisition server at Geocomp Headquarters in Boxborough, MA. The initial readings of all instrumentations before the load test were recorded. Survey station prisms were installed at M19 eastbound and westbound, M17 eastbound, and M20 eastbound to monitor the movements of footings and bent caps of the M19 piers using an automated laser survey system. Figure 1 presents a photo of the load test site at M19 eastbound and westbound piers.

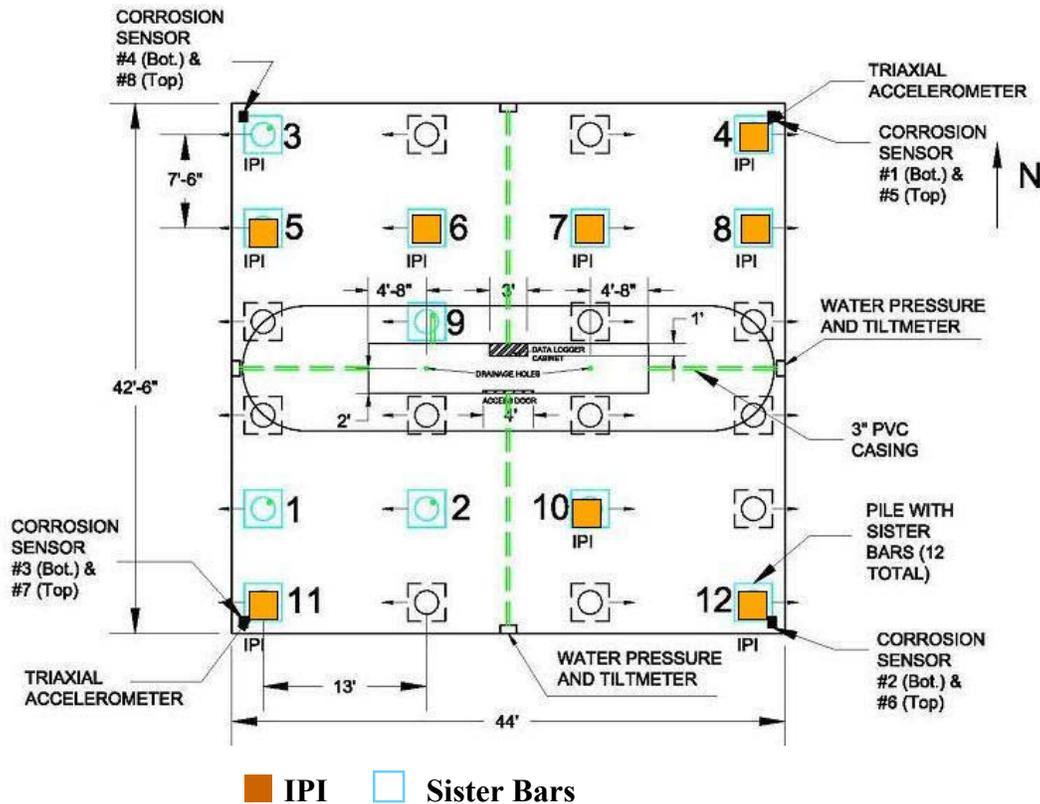
The substructure monitoring system includes instrumenting eight selected piles with inclinometers and strain gauges and instrumenting the pile-cap with accelerometers, tiltmeters, water pressure cells, and corrosion meters as described next. A plan view of M19 footing with the layout of substructure instrumentation is presented in Figure 2. The superstructure monitoring system includes instrumenting columns, bent cap, three steel girders, three concrete girders, and

Figure 2. Plan View of M19 Pier Footing with Layout of Substructure Instrumentation

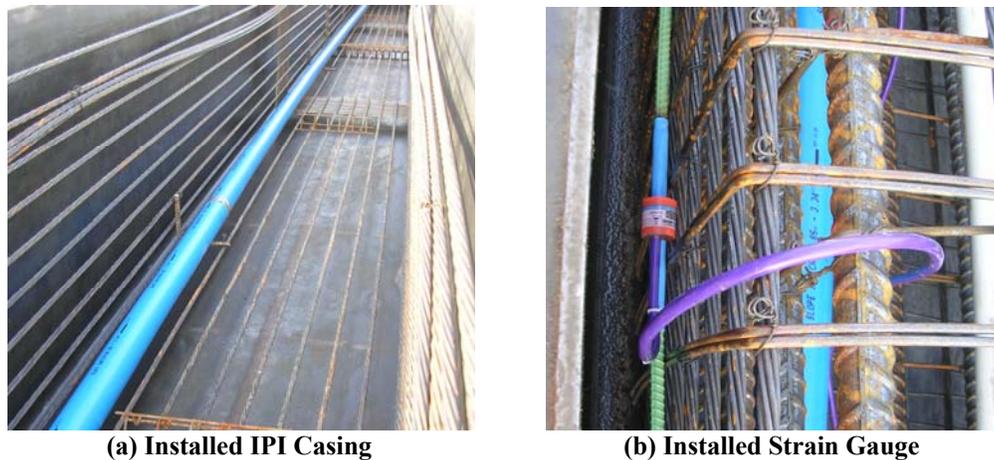
Eight selected piles (numbers 4, 5, 6, 7, 8, 10, 11, and 12) were instrumented with In-Place Inclinometers (IPI) Micro Electro Mechanical Sensor (MEMS) sensors. IPI consists of a string “node” of tilt sensors connected together and placed in the pile foundation through a PVC casing. It can measure the position change (inclination) in each node in a direction perpendicular to the axis of the string. Each pile was instrumented with six inclinometer sensors located at elevations of -65, -45, -35, -25, -15, and -5 ft. from the bottom level of the pile cap.

Twelve selected piles (numbers 1, 2, 3, 4, 5, 6, 7, 8, 9, 10, 11, and 12) were instrumented with resistance type sister bar strain gauges to measure the strain distribution at the locations close to the pile cap caused by the applied lateral load. Each pile was instrumented with two pairs of strain gauges at -16 ft. and -21 ft. from the top of the pile in the casting yard. Figure 3 presents photos of pile instrumentations during pile casting. The piles’ strain changes were monitored during casting, strand cutting, and storage. Pile 1 was also instrumented with data logger to monitor the strain change during delivery (Figure 4). It can be seen that the pile experienced appreciable strain change only when the pile was moved for storage (August) and when the pile was moved to barge for delivery (end of October).

Figure 3. Pile Instrumentation

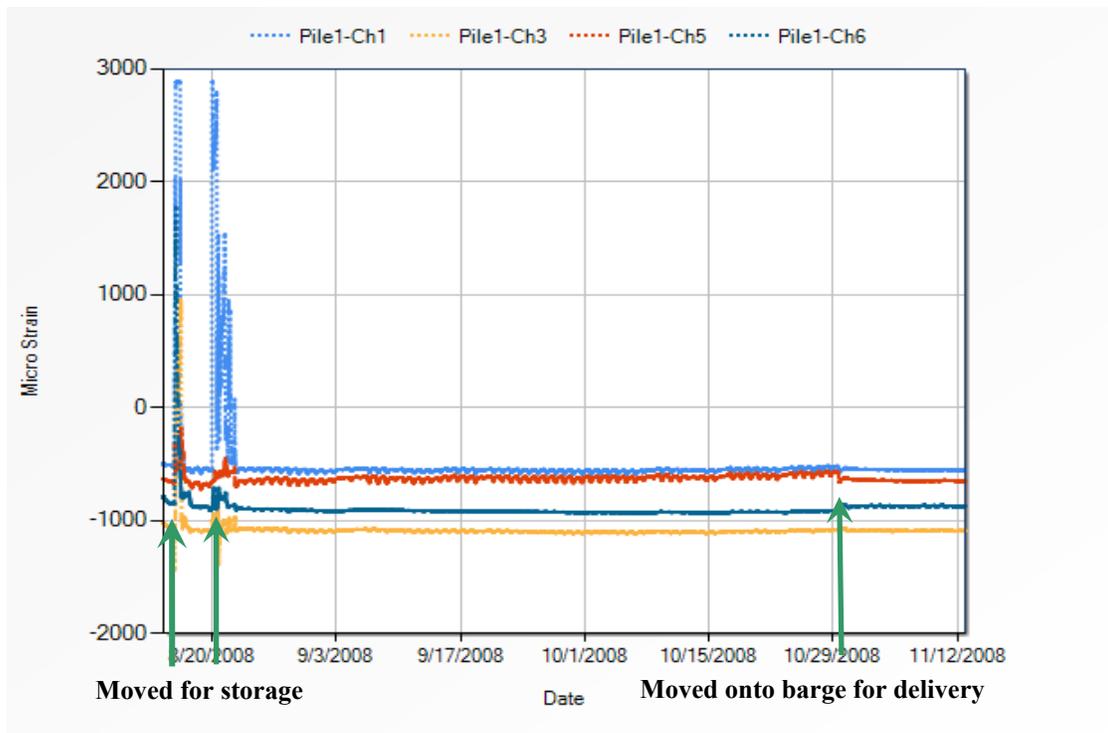
Figure 4. Recorded Strain Change for Pile 1 during Storage and Delivery

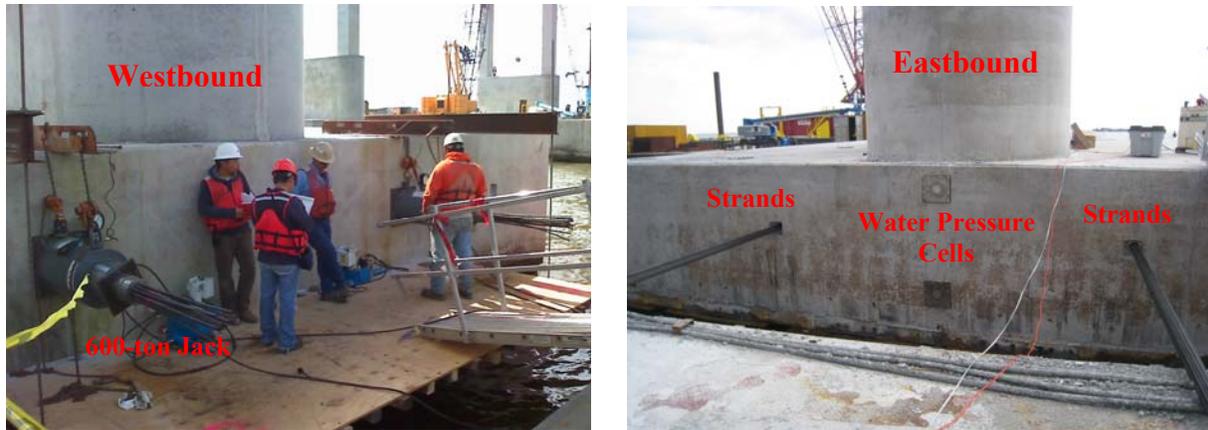
The setup of the lateral load test started two days before the test. Two floating barges were deployed to the site. One barge was placed between the two pile caps to allow access and to provide support to steel strand tendons to eliminate slack and keep them out of water. Another barge was placed next to M19 westbound to carry jacking/hydraulic equipment setup and to allow access to the live-end side. The steel strands were run through 4-in. PVC pipes one by one from the dead-end at M19 eastbound toward the live-end at M19 westbound. Steel strands were first anchored at the dead-end side. A 600-ton jack was installed for each steel tendon at the live-end. The strands were anchored at the live-end, and then each strand was pre-loaded to 2 kips using two 10-ton monostrand jacks. Figure 5 presents photos for the setup of the lateral load test.

(a) Jacking System at the Live-End of Westbound Pier (b) Eastbound Pier with Steel Strand Tendons

Figure 5. Setup of Lateral Load Test

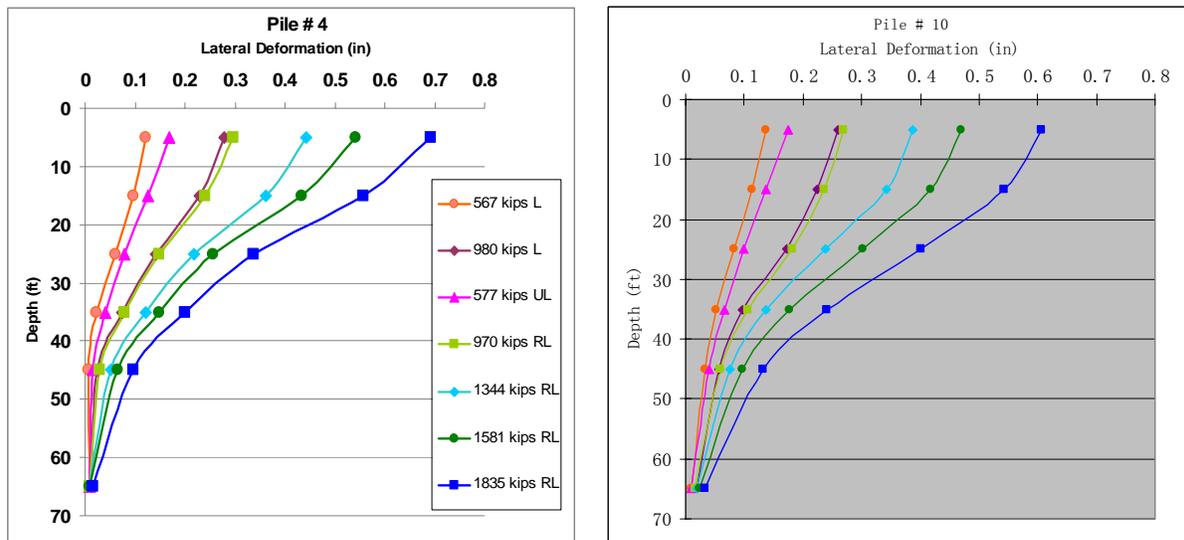
The profiles of lateral deformations for piles 4 and 10 measured using IPI inclinometers at different applied loads are presented in Figure 6a and b. The figure indicates that most of the lateral deformation occurred within the upper 50 ft. of the piles' length. The maximum lateral deformation measure at 5 ft. from the bottom level of the pile cap ranged from 0.60 in. to 0.72 in. This is in agreement with the measured lateral deformations of the pile cap using the automated laser survey, which are 0.66 in. and 0.58 in. for northwest and southwest corners of the M19 eastbound pier, respectively. The success rate of strain gauges and IPI instrumentations were about 70 percent.

Figure 6. Profiles of Lateral Deformation for Piles 4 and 10 with Load Increments

The substructure instrumentation system was successfully installed and used to monitor the M19 eastbound pier during the lateral load test. The preparation and design of the lateral load testing were discussed. The test was conducted by pulling the M19 eastbound and westbound piers toward each other using high strength steel tendons using two 600-ton jacks. The horizontal movements of the pier caps and bents were monitored using an automated survey. A maximum lateral load of 1870 kips was applied in increments, and the corresponding maximum lateral deformation of the M19 eastbound pier cap as measured using the laser survey was 0.66 in. at the northwest corner and 0.58 in. at the southwest corner. The maximum lateral deformation of piles measured at 5 ft. from the bottom level of the pile cap using IPI sensors ranged from 0.65 in. to 0.72 in.
