Arizona Public Service
Company

La Paz County, AZ

Background & Project Challenges

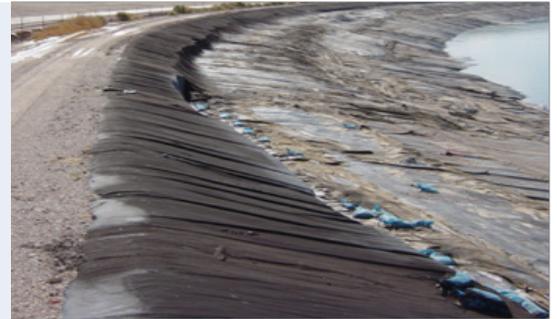
The Palo Verde Nuclear Generating Facility is the largest nuclear plant in the U.S. In 1991, rehabilitation was conducted to repair the damaged geomembrane liner of the existing 80-acre reservoir which stores emergency cooling water for the nuclear power facility. At least half of the reservoir volume had to be maintained at all times. The project team was considering an inflated membrane structure to work as a coffer dam over part of the reservoir. This would allow dewatering of part of the reservoir so that the existing liner could be replaced. The inflated membrane structure would be reused on other parts of the reservoir to replace the entire liner.

Geocomp evaluated the internal stability of the proposed inflated structure as well as the overall stability of the structure and its foundation. The existing bottom liner used a rubberized asphalt layer. Geocomp found that this material creeps at a high rate under relatively low shear rates. A detailed numerical analysis showed that the inflated structure would not be stable for the required loading conditions. While an appealing solution from cost and operational perspectives, this option would have failed during construction.
