Wilkinson County Slope Failure Remote *iSiteCentral*™ Automated Monitoring

- Instrument and monitor roadway movement during construction

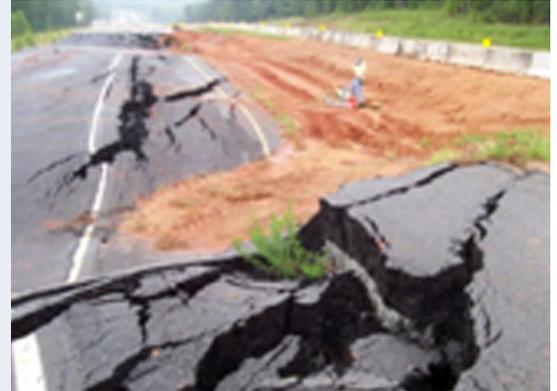
A roadway embankment in rural Wilkinson County, Georgia had failed and been moving for years. As part of the design/build repair contract, the construction team wanted to know the depths and extent of movement of the slope in four areas in and around the massive slope movement.

The monitoring locations were selected by the designer of the remedial work brought on board to fix the slope. Inclinator casings were installed in soil test borings to depths of about 60 feet.

Geocomp provided initial manual readings of the inclinometers to measure horizontal movement with depth, and automated readings using in-place inclinometers to monitor horizontal movement over a period of two months. Geocomp provided the data on the *iSiteCentral*™ website using two *iSite*™ loggers that transmitted data via radios and cell phones.

During several heavy rain events in September 2009, the team was able to observe significant movement within one day. The automated inclinometer readings were taken each hour and a large amount of data was provided over the two months of monitoring. Using the automated *iSite*™ loggers and software was less expensive than providing manual readings once a week and it provided as many as 24 readings per day at each of the four locations.
