Technologies to manage risk for infrastructure

Ellis Square Parking Garage

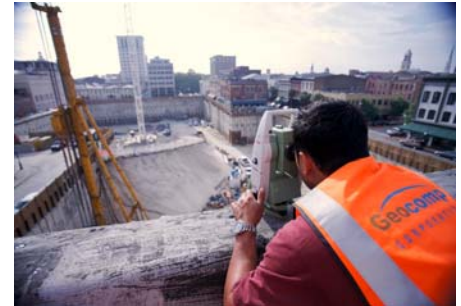
Training targets for AMTS monitoring

ing Leica automated total stations with reflective targets and in-place inclinometers to monitor movements of the excavation support system and adjacent buildings around the clock. This system provided immediate indication of the deformations resulting from specific construction activities and helped identify causes of additional movements to bring them under control.

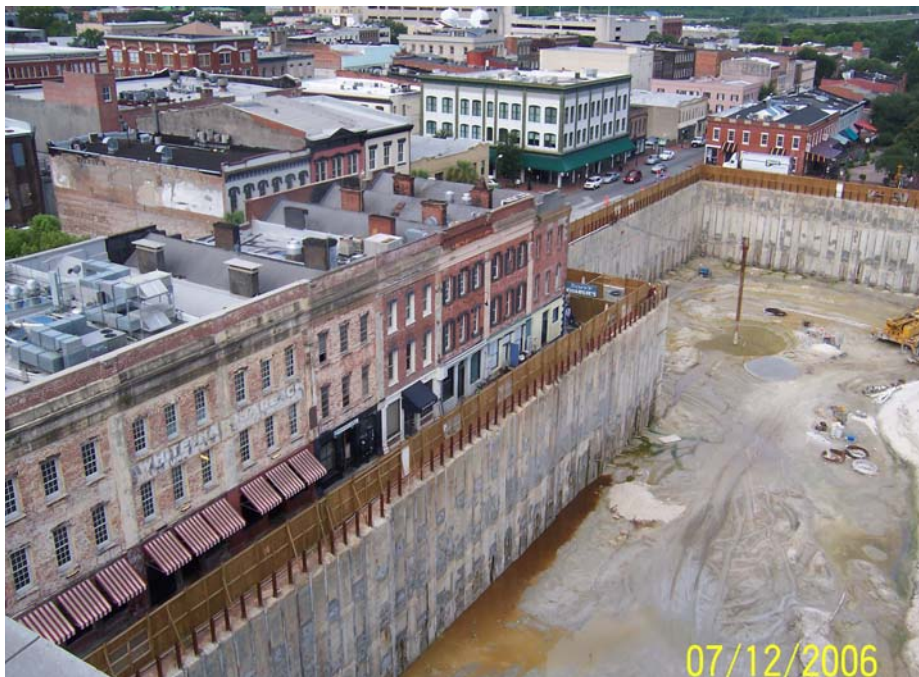
Historic buildings within feet of 45-ft. deep excavation
